Manhole Inspection Summary

Manhole # S19M__042MH

Location Address: **500 smallwood-alley-bentalou**

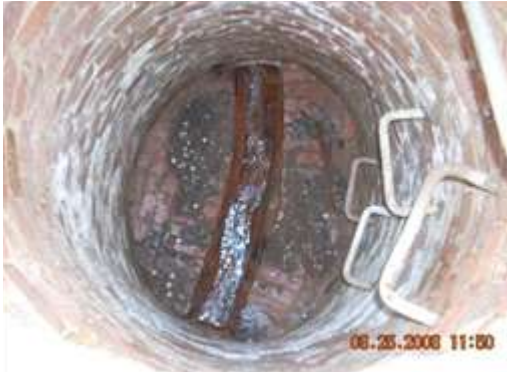
misc

bench debris

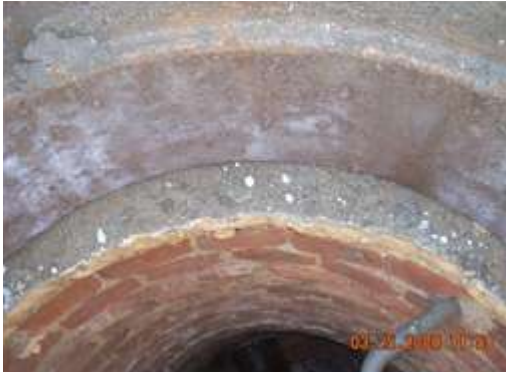
Defect 1

Frame Offset: **2** (in.) Condition: ☒ Sound ☐ Cracked ☐ Leaks

frame offset

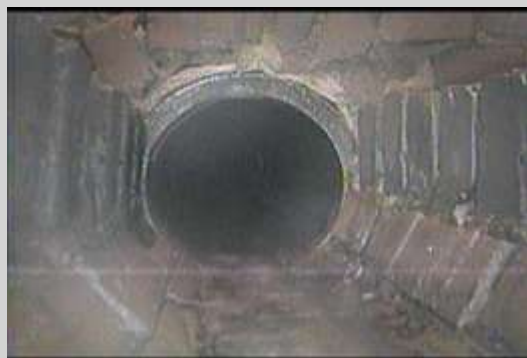
12 O'Clock Outflow

8 in. Circular Gravity Sewer
Pipe Out @ 12 O'Clock

Pipe Height: **8.4** (in.) Rod and Bar (Angled)
Pipe Material: **Clay** ☐ Pipe Lined
Invert Depth: **9.30** (ft.) Flow Characteristics: **Slow**
Deposits: ☒ None ☐ Mud ☐ Sludge ☐ Debris ☐ Grease
Silt Depth: **0** (in.) Deposits Extent:
Infiltration: **None** Pipe Seal Cond: **Sound**

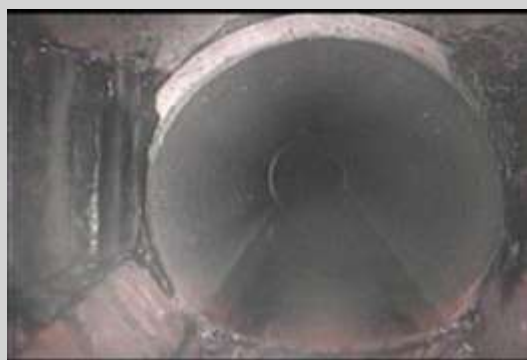
7 O'Clock Inflow

8 in. Circular Gravity Sewer
Pipe In @ 7 O'Clock

Pipe Height: **8.4** (in.) Rod and Bar (Angled)
Pipe Material: **Clay** ☐ Pipe Lined
Invert Depth: **9.06** (ft.) Flow Characteristics: **Slow**
Deposits: ☒ None ☐ Mud ☐ Sludge ☐ Debris ☐ Grease
Silt Depth: **0** (in.) Deposits Extent:
Infiltration: **None** Pipe Seal Cond: **Sound**
